Kettle Creek Conservation Authority

Watershed
Report Card 2008

OVERALL WATERSHED GRADE

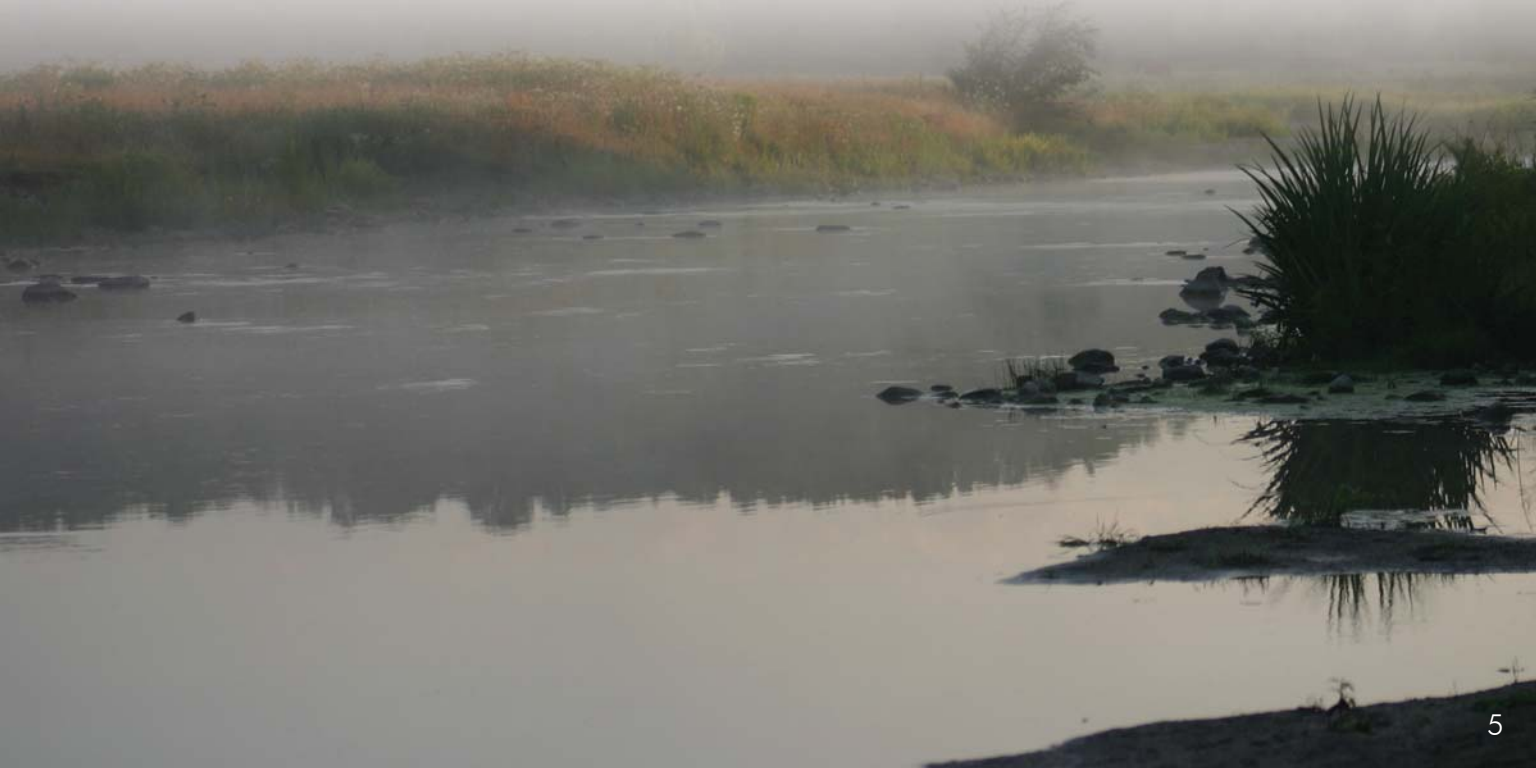
KETTLE CREEK SUBWATERSHEDS

The 2008 watershed report card utilizes data gathered between 2003 and 2007. In some cases, historical data was used where information gaps occurred. For the purposes of the report card, the Kettle Creek watershed was divided into three subwatersheds: Dodd Creek, Upper Kettle Creek and Lower Kettle Creek. Each subwatershed has unique features relative to their land base and land use that affect the grading of the watershed report card.

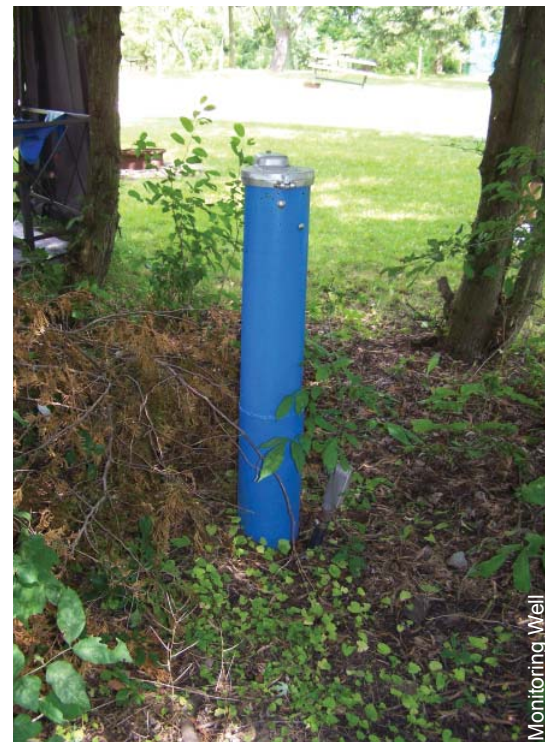
Monitoring Well

Groundwater is the water found below the earth's surface in the soil, wells, porous rocks and aquifers. Seven monitoring wells have been established in the KCCA watershed. Water samples are collected each spring and fall and are tested for a variety of parameters including: nutrients, metals and bacteria. KCCA first collected groundwater data from the monitoring wells in 2003 in partnership with the MOE's Provincial Groundwater Monitoring Network (PGMN). The groundwater monitoring program must continue sampling for several years to collect enough data to make a meaningful conclusion regarding the status of groundwater quality. However, preliminary results are excellent across all three subwatersheds. Chloride (salt) levels are well below the Environment

It is important to note that the grades are only a reflection of the water quality measured within each well and cannot be used to assess groundwater quality beyond the actual well. KCCA needs to add additional monitoring wells to both the Dodd Creek and Lower Kettle Creek subwatersheds to expand the monitoring program and gain a better understanding of the groundwater conditions within the watershed.

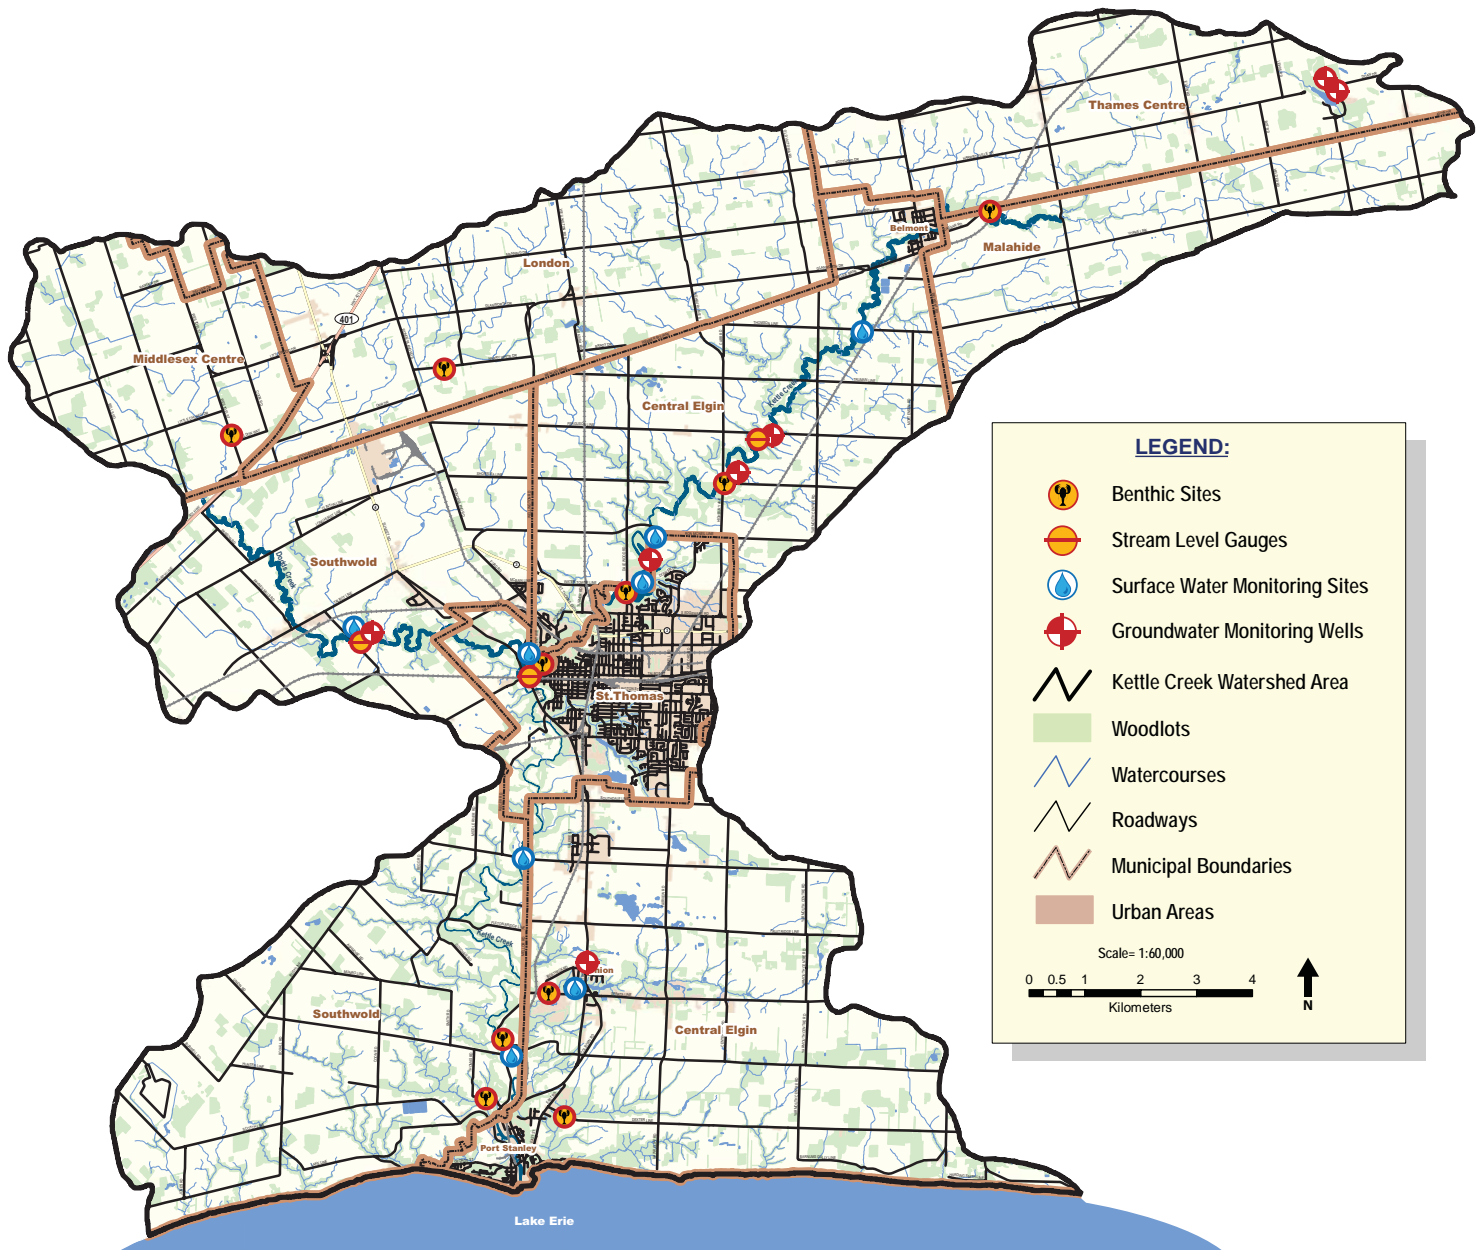
WATERSHED MONITORING SITES

-   Benthic Sites
-   Stream Level Gauges
-   Surface Water Monitoring Sites
-   Groundwater Monitoring Wells
-   Kettle Creek Watershed Area
-   Woodlots
-   Watercourses
-   Roadways
-   Municipal Boundaries
-   Urban Areas
