# 2013 WATERSHED REPORT CARD

Kettle Creek  
Conservation Authority

OVERALL WATERSHED GRADE

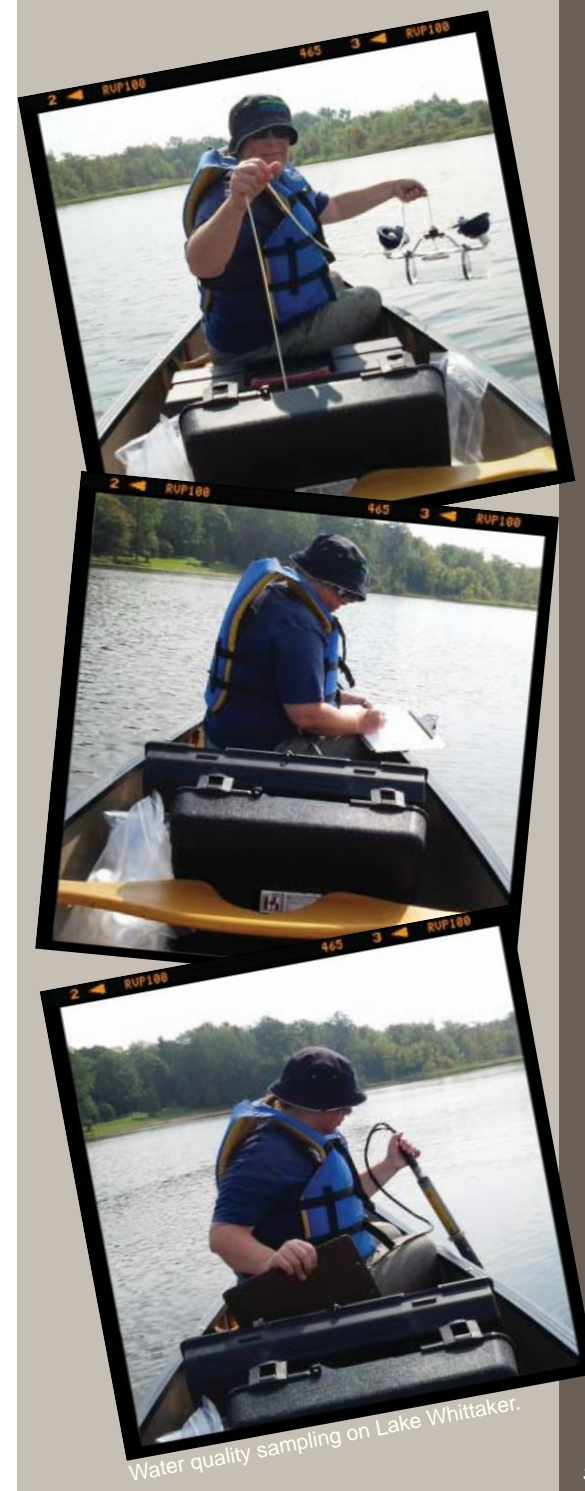
Water quality sampling on Lake Whittaker.

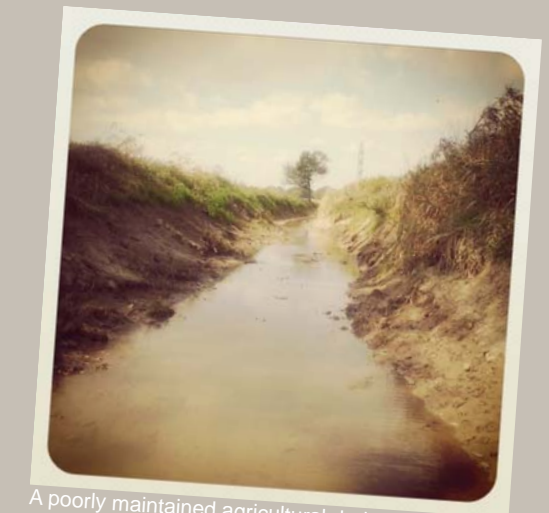
A poorly maintained agricultural drain.

Priority stewardship activities in the Dodd Creek subwatershed must focus on erosion prevention, wetland and riparian restoration and drain maintenance.

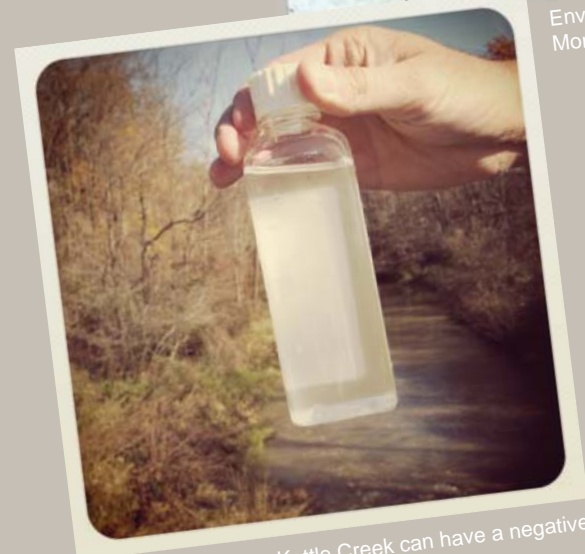
Poor water quality in Kettle Creek can have a negative impact on the nearshore of Lake Erie.

One of the biggest concerns in the lower part of the watershed is the effect of Kettle Creek's water quality on the nearshore of Lake Erie, which is a major source of drinking water.
